Lower Red River Meadow Restoration Project

Effectiveness Monitoring

Technical Report 1997 - 2001

DOE/BP-00004478-1

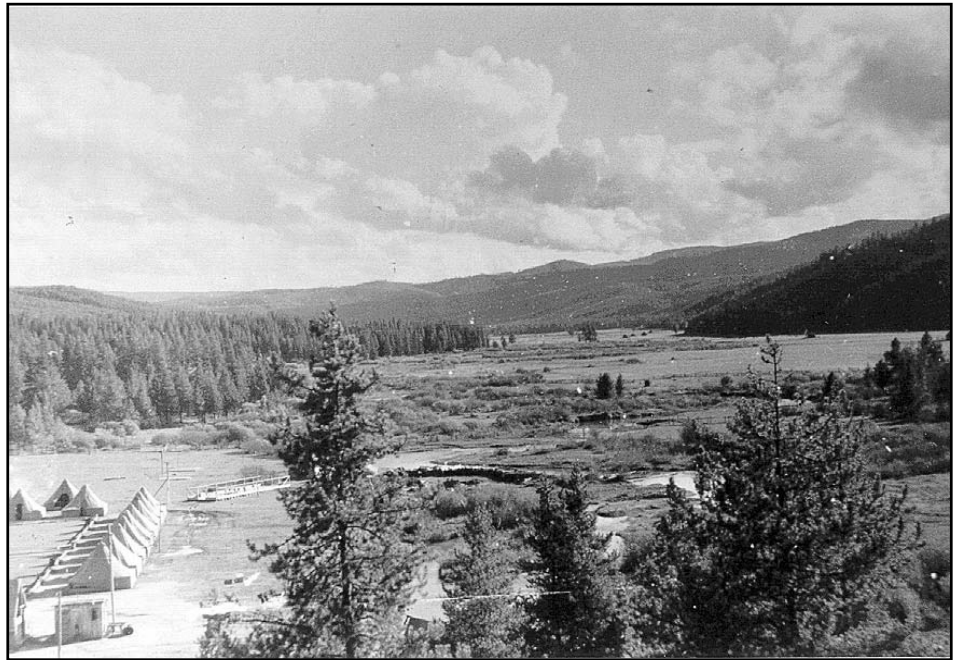
The Lower Red River Meadow was the location of a Civilian Conservation Corps (CCC) camp in 1939. Notice the dense riparian shrub communities along the river channel (looking southwest).

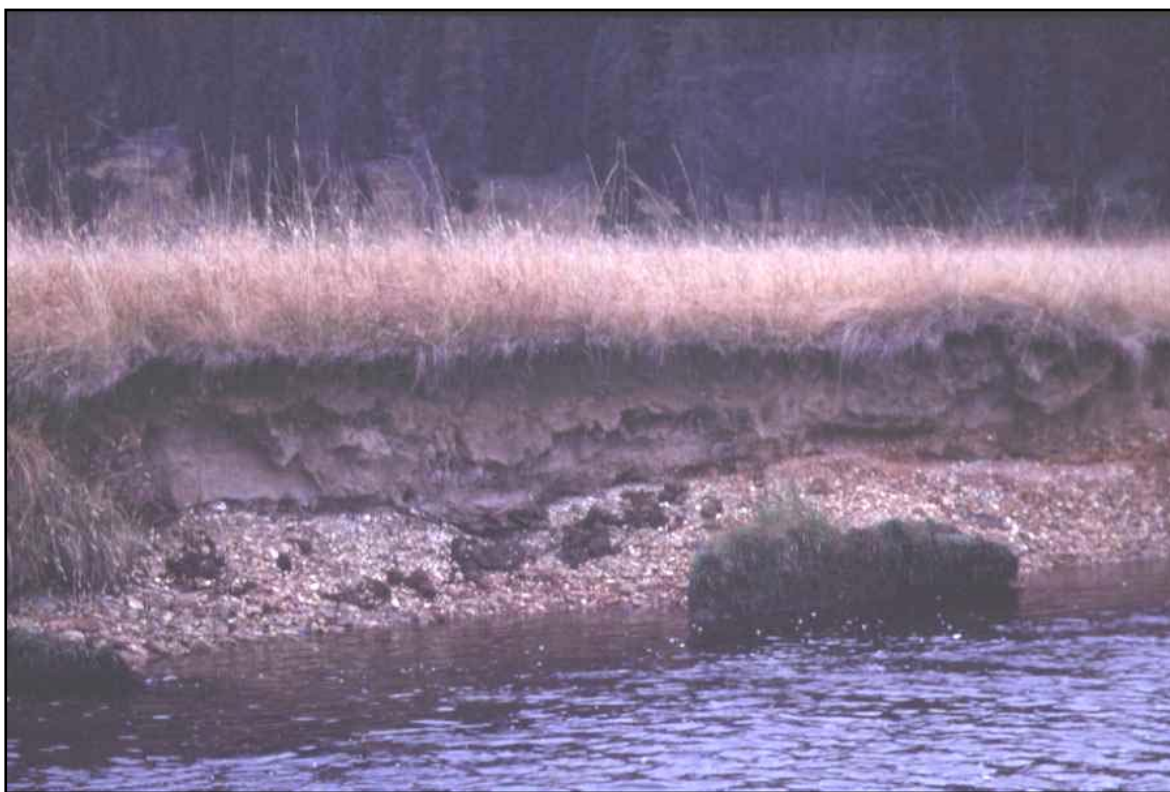
Figure 3.4 A typical outside bank in the Lower Red River Meadow where shallow rooted, nonnative pasture grasses are unable to bind the streambank soils against the forces of erosion. The coarse-textured, sand/gravel subsurface layer is easily scoured out and eventually followed by collapse of the surface soil layer.

BANK STABILITY. Nearly every outside bend is characterized by an over-steepened, unstable vertical cut created primarily by accelerated erosional forces. Bank sloughing and collapse are common, exacerbated by the existing shallow, fine-rooted vegetation unable to bind the soils or form stable undercut banks. In addition, the coarse-textured sand/gravel subsurface layer is highly susceptible to erosive forces. Loss of this subsurface material eventually causes undermining of the surface layer and subsequent bank collapse (Figure 3.4).

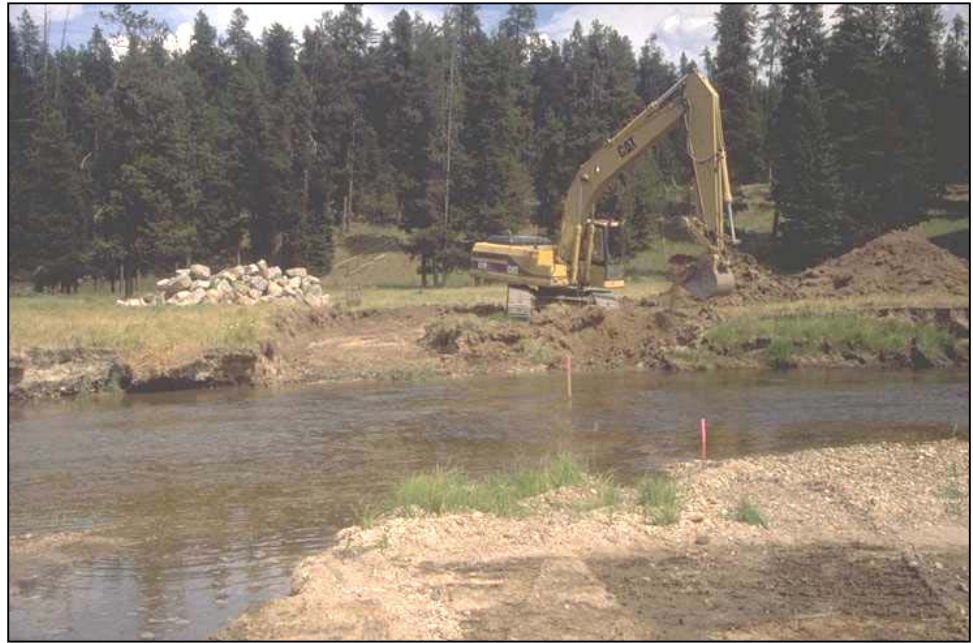
Track excavator digs a dry channel named Big Bend. Adding length to the river by creating new meanders and reconnecting historic meanders decreases the stream gradient, slows water velocities, and reduces local streambank and bed erosion rates.

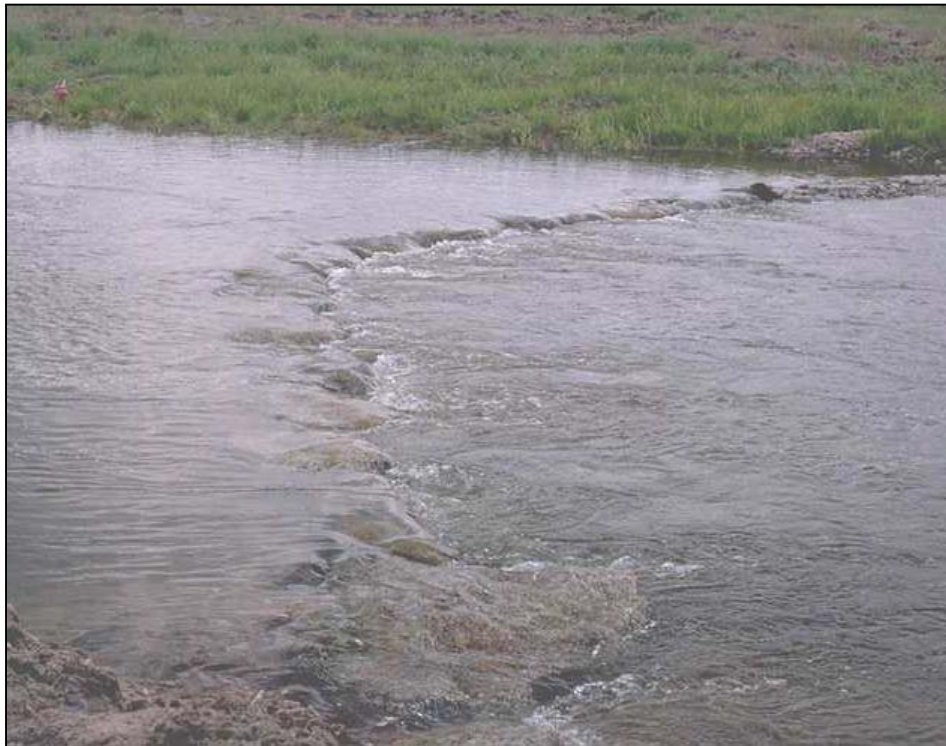
Figure 4.5. Finished rock grade control structure in Phase I, Lower Red River Meadow Restoration Project. Water flow is from left to right in this photograph.

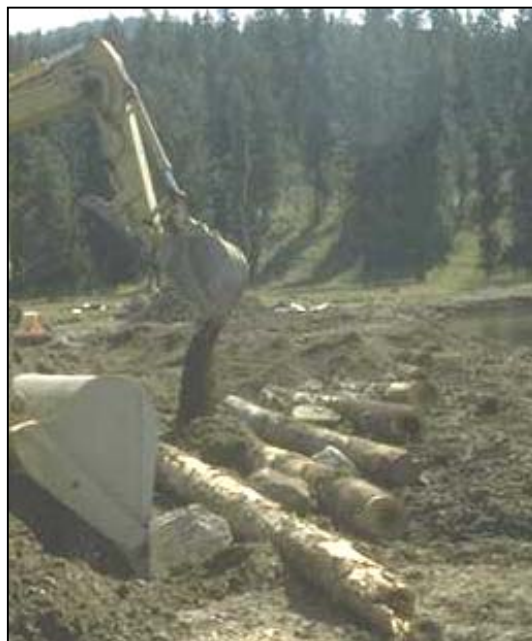
Figure 4.7. Track excavators install a log and rock reinforced bank.

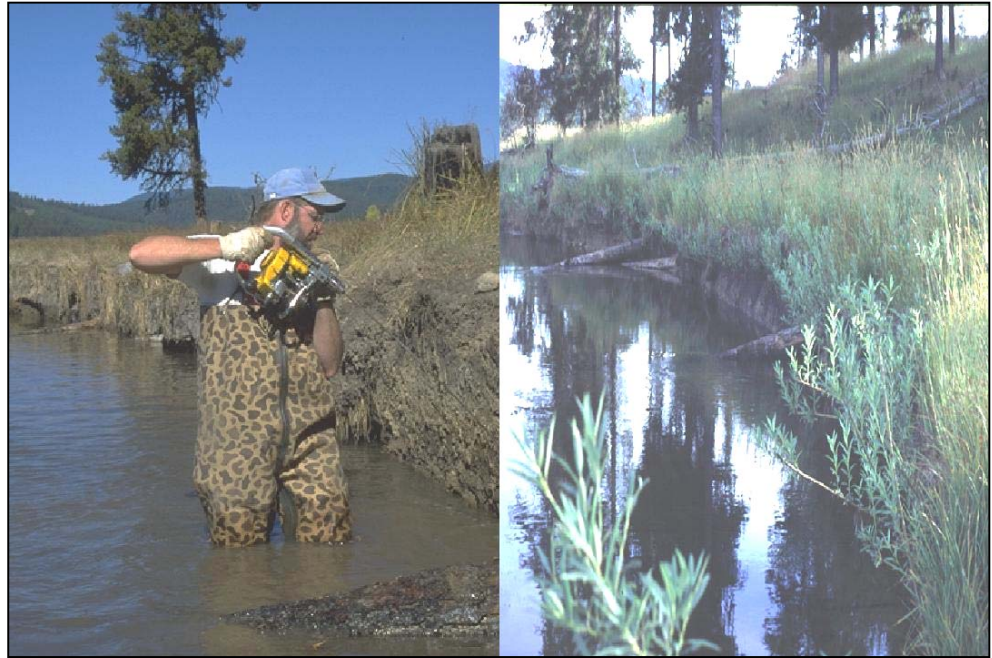
Planting willows in reconstructed channel (left). Willow growth on same bank, one year later (right).

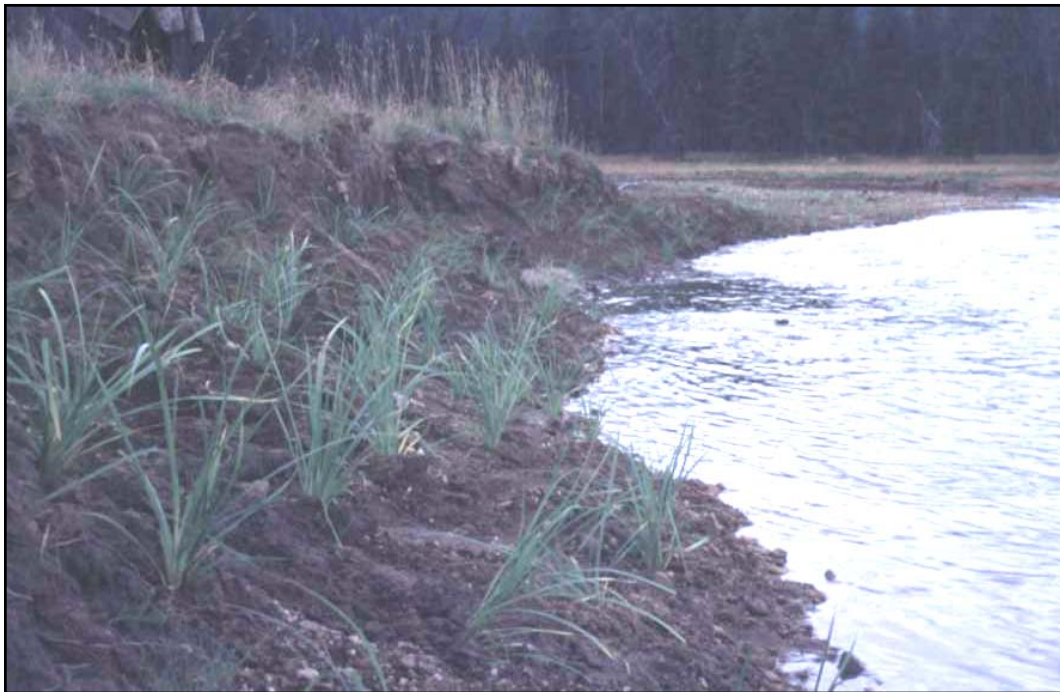
Figure 5.4. Native, water-loving small-fruited bulrush are planted into exposed soil of an outside bend in Phase I, RRWMA, Lower Red River Meadow Restoration Project.

Herbaceous plants are also placed according to their specific hydrologic and other known habitat requirements. Dagger-leaf rush, Coville's rush, and small-fruited bulrush are planted at or near the water's edge (Figure 5.4). Colorado rush and small-winged sedge are planted in dryer sites on top of the banks or terraces. Lens and beaked sedge are planted into the slumped areas of cut banks (Figure 5.3) and in off-channel water-holding depressions.

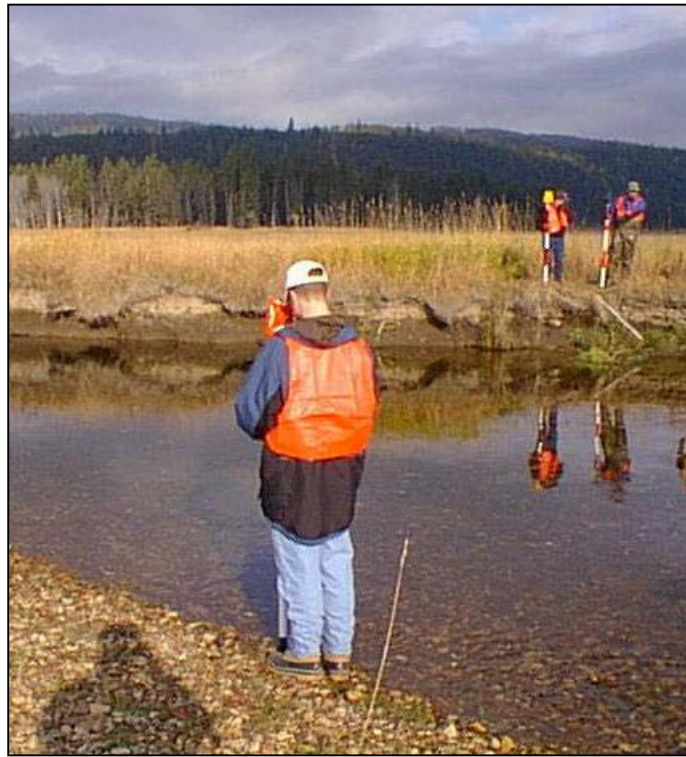
University of Idaho students survey channel cross-sections. Data collected from the survey is used to evaluate stream channel response to restoration activities.
